Mechatronics, Electrical Power, and Vehicular Technology

QUALITY EVALUATION OF THE MODIFIED DIESEL-ELECTRIC TRAIN (KRDE)

Abstract

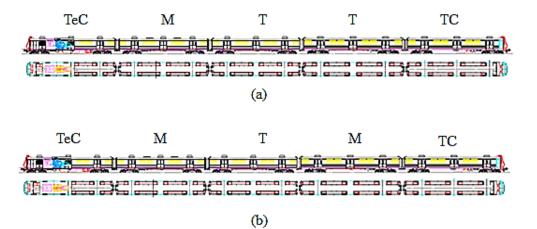
A rail diesel train (KRD) has its own drive train whose power is provided by its diesel power source. A diesel electric train (KRDE) is one type of KRD that uses electric power transmission (generator, electric power control and electric motor) [4, 5]. In 2005, modification of electric trains (KRL) into diesel electric trains (KRDE) has been conducted. Figure 1 (a) shows a modified version KRDE from KRL type A, and (b) shows a push-pull KRDE modified from KRL type B. The configuration difference between both types of KRDE can be seen in Figure 2 [6, 7], while the captions are TeC: Car Trailer with diesel generator sets and cab driver, M: Motor

Car with inverters and traction motors, T: Car Trailer, and TC: Car Trailer with cab driver.

Figure 2. Configuration difference between both types of KRDE

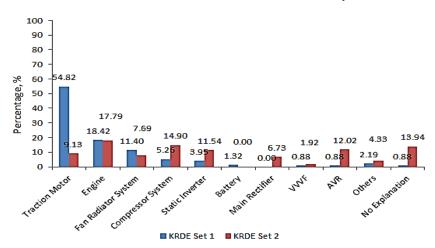
Figure 5. TSO causes of KRDE Arek Surokerto Set-1 and Set-2

TSO causes of KRDE Arek Surokerto can be seen in Figure 5. It impaired and damage due to the traction motors dominated the causes of TSO of KRDE set 1, while KRDE set 2 is dominated by the engine problems.
